trouble shooting tips

TST 15

Sealing D&H Technologies Pulsers to Prevent Water Wicking up Shaft

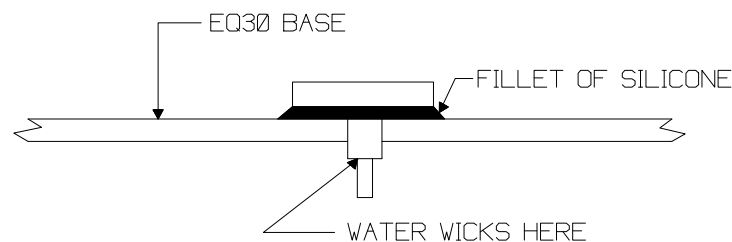
Water is the biggest cause of Pulser Failure on D&H EQ30 Heads! Almost 90 percent of the units being returned under warranty have signs of moisture having been present on their shaft.

We think the problem comes from condensation forming on the metal plate on which the Pulser is mounted, then running down under the Pulser and down it's shaft where it "wicks" up the shaft and into the Pulser.

We suggest sealing the Pulser after it is mounted by running a bead of silicon around it to prevent water getting underneath it (see Figure 1 below). We are ensuring that any Pulsers shipped from National Parts Distributing Ltd. have been sealed at any joints in the Pulser and where the wires enter the Pulser. If you have a Pulser which is not sealed you should also seal all joints on the body and where the wires enter with silicone.
