Troubleshooting Tips

#15 – Sealing MTI (D&H) Pulsers to Prevent Water Damage

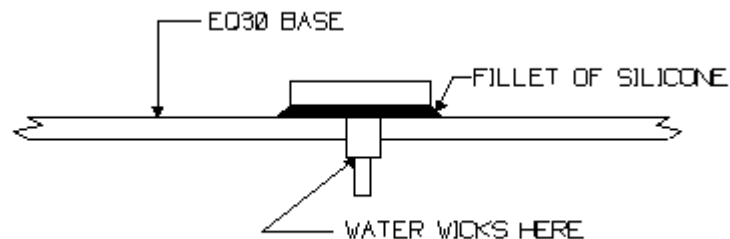
Water is the biggest cause of Pulsar Failure on D&H EQ30 Heads. Almost 90 percent of the units being returned under warranty have signs of moisture having been present on their shaft.

We think the problem comes from condensation forming on the metal plate on which the Pulsar is mounted, then running down under the Pulsar and down it's shaft where it "wicks" up the shaft and into the Pulsar.

We suggest sealing the Pulsar after it is mounted by running a bead of silicon around it to prevent water getting underneath it (see Figure 1 below). We are ensuring that any Pulsars shipped from National Parts Distributing Ltd. have been sealed at any joints in the Pulsar and where the wires enter the Pulsar. If you have a Pulsar which is not sealed you should also seal all joints on the body and where the wires enter with silicone.
