National Parts Distributing Ltd

trouble shooting tips

Service Station Maintenance

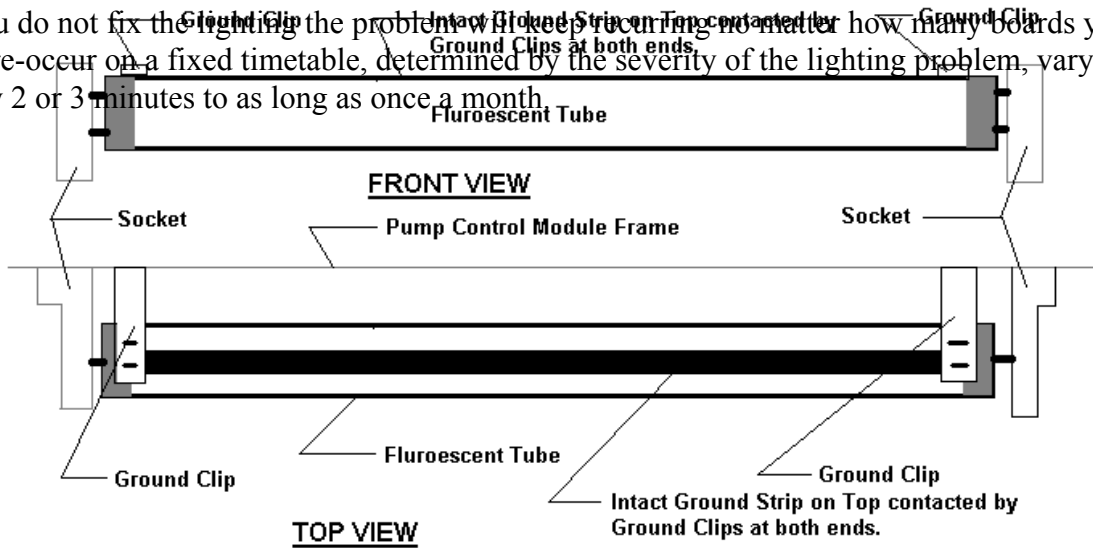
Figure 1

It should be noted that any light driven by a ballast such as fluorescent's, mercury vapour, etc. can cause this problem, and any such light within 20 to 30 feet of the pump can be the guilty party.

Any light that is flickering or has darkened ends, or especially any that are out, can cause the problem.

If you do not fix the lighting the problem will keep occurring no matter how many boards you change. It will re-occur on a fixed timetable, determined by the severity of the lighting problem, varying from every 2 or 3 minutes to as long as once a month.

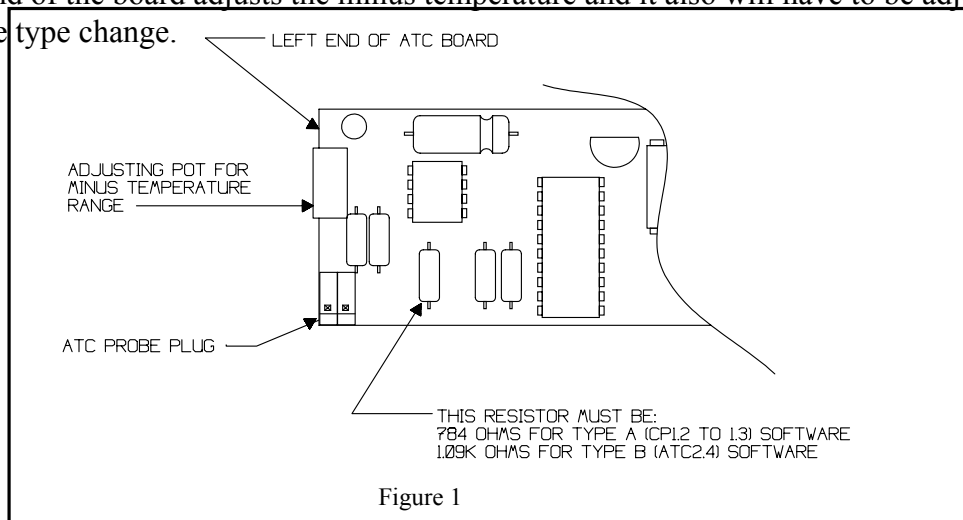
If this is done without changing the resistor closest to the right of the ATC Probe Plug on the SKIL 184 ATC Board (as shown in figure 1) it will result in the plus temperature range being out of compensation. It will be further out the higher the temperature.

The resistor must be a 784 Ohm for Type A (CP1.2) Software and 1.09K (1090) Ohm for Type B (ATC2.4) Software. Other values will give compensation error.

ERI can change these resistors for you and test the board for operation with the software you will be putting into service!

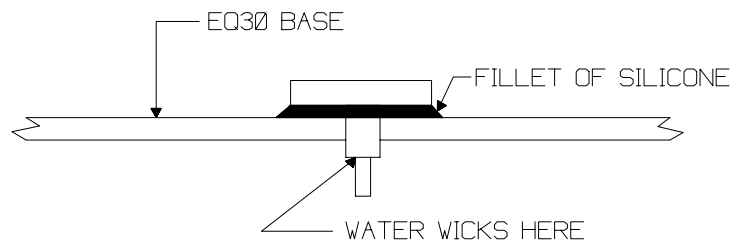
Water is the biggest cause of Pulsar Failure on D&H EQ30 Heads! Almost 90 percent of the units being returned under warranty have signs of moisture having been present on their shaft.

We think the problem comes from condensation forming on the metal plate on which the Pulsar is mounted, then running down under the Pulsar and down it's shaft where it "wicks" up the shaft and into the Pulsar.

We suggest sealing the Pulsar after it is mounted by running a bead of silicon around it to prevent water getting underneath it (see Figure 1 below). We are ensuring that any Pulsars shipped from National Parts Distributing Ltd. have been sealed at any joints in the Pulsar and where the wires enter the Pulsar. If you have a Pulsar which is not sealed you should also seal all joints on the body and where the wires enter with silicone.

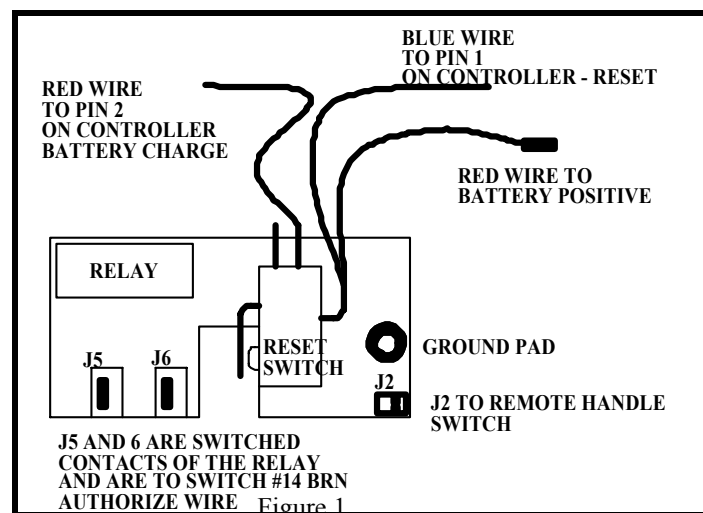
Check the voltage between the red wire coming from Pin 2 (see Figure 1 below) on the Controller and the ground pad on the board with an accurate multi meter. The voltage should be 7.0 VDC. If the voltage is less than 6.75 VDC the relay will not engage.

If the voltage is low (above 4.5 VDC) the head will probably be trying to reset but because the authorize is not happening the head will not reset. Short the wires connected to J5 and J6 and see if the head will reset. ***If it will the board is probably not faulty.***

If the power is low it will be caused by a faulty battery or by a faulty controller board.

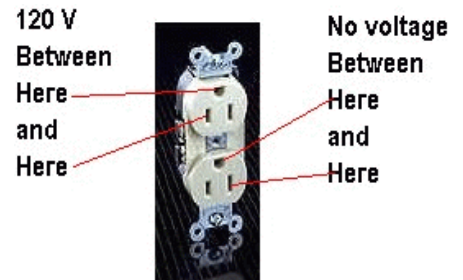
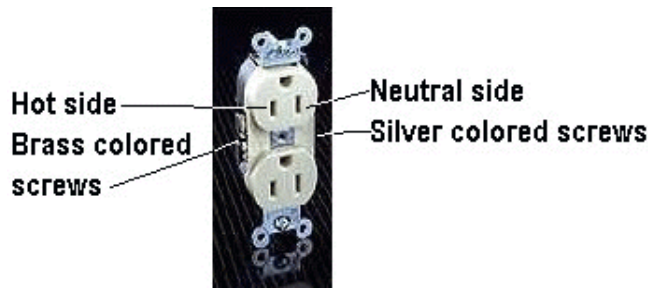
An outlet should be wired such that the HOT lead is connected to a specific side of the outlet, and the neutral lead to the other. This is done for safety reasons. Also in most systems the Ground and the Neutral are connected together at the Breaker Panel. Most consoles and Printers also reference their Ground to Neutral. Switches on the things you plug into the outlet will open and close the HOT side, so when the switch is off, there will be no voltage inside the device. The HOT side, should be the smaller of the two openings on the outlet. The neutral will be the wider of the two. Cords where it matters will have one of the prongs wider so the neutral side and hot side line up correctly. They will also in most cases have a Ground Pin located correctly.

How can you tell? Use a voltmeter, and check the voltage between the narrow opening and the ground opening. It should measure about 110-125V. Measure the voltage between the wider opening and the ground. It should be zero. If your readings are reversed, your polarity is reversed.

How do you correct this if your polarity is reversed? Turn the power off to the outlet by opening the breaker or pulling the fuse. Check the outlet again to be sure it is dead. Remove the outlet, the hot wire, (should be the black wire) probably is connected to the silver colored screw. It SHOULD be connected to the brass colored screw. If you look at the outlet, the brass screws are on

the same side of the outlet as the shorter plug opening. Swap the wires that feed the outlet Black (hot) wire to the brass colored screw, and white (neutral) wire to the silver colored screw. Tighten the screws securely. (By the way, wrap the wire around the screw in the clockwise direction, it prevents it from twisting off as you tighten the screw.) Re-install the outlet.
