National Parts Distributing Ltd

trouble shooting tips

Service Station Maintenance

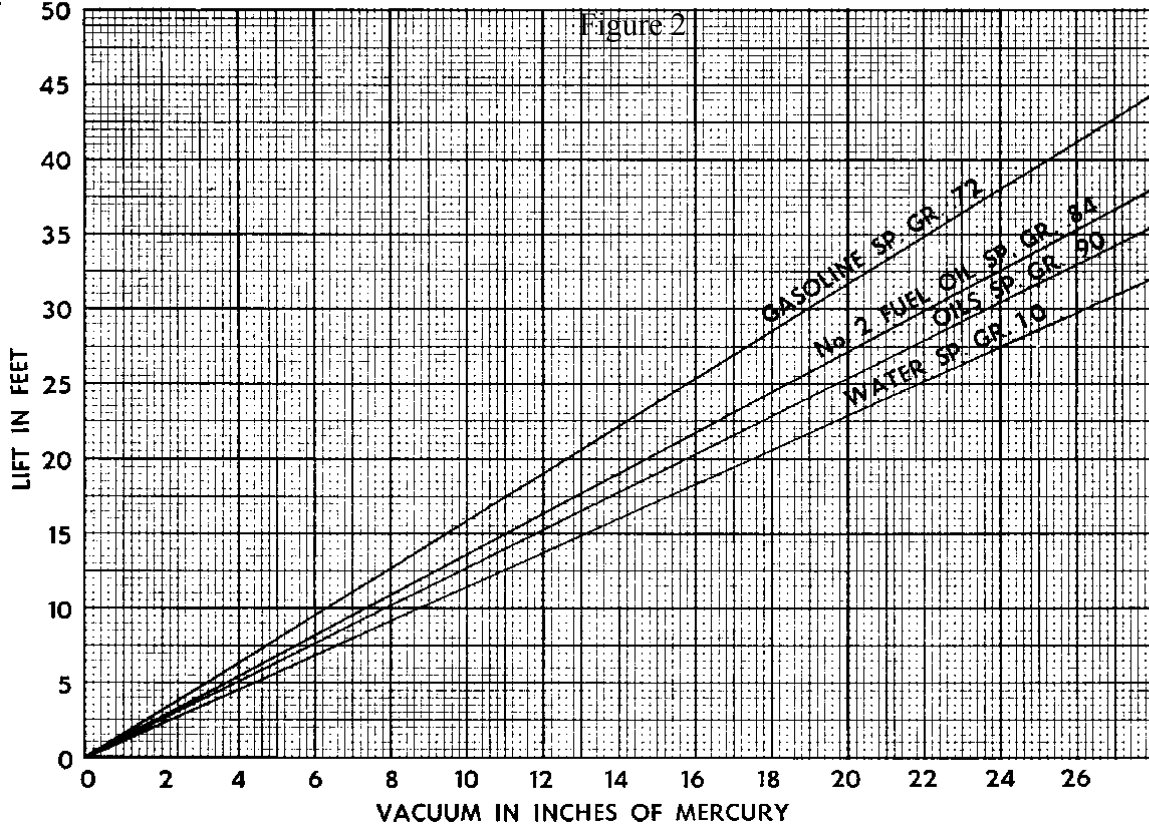
Figure 3

- a. Height from C/L to liquid level is measured at 11 feet. From Curve (figure 3 at end of document) we see this is equal to 6.6 in. Hg.(Mercury).
b. We determine that there is 60 feet of 2 in. pipe with 6 - 2 in 90 Deg. SR elbows. From Figure 2 we can determine that each elbow is equal to 5 feet of pipe. This gives us:
